# Restaurant Væksthuset (Denmark)

## Project description

## mageba scope

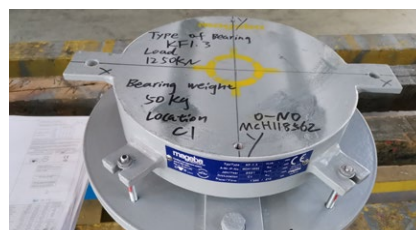
All bearings were manufactured in mageba’s Shanghai production facility

Following the design of the products, they were fabricated in mageba’s Shanghai factory and shipped to Copenhagen.

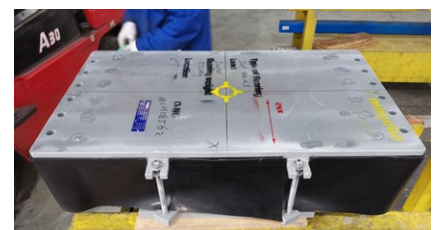
One of the spherical bearings featuring dust skirts

The bearings installed on the columns of the building were designed in such a way that they provide vertical support to the lightweight roof, in both gravity and uplift scenarios, whilst simultaneously guiding horizontal forces and allowing movements as required by the structure.
